CSX Kanawha Trestle Inspection Report Charleston, West Virginia

Michael Baker Jr., Inc.

August, 2011

**UNDERWATER INSPECTION
OF
KANAWHA TRESTLE
KANAWHA RIVER PIERS
IN
CHARLESTON, WEST VIRGINIA**

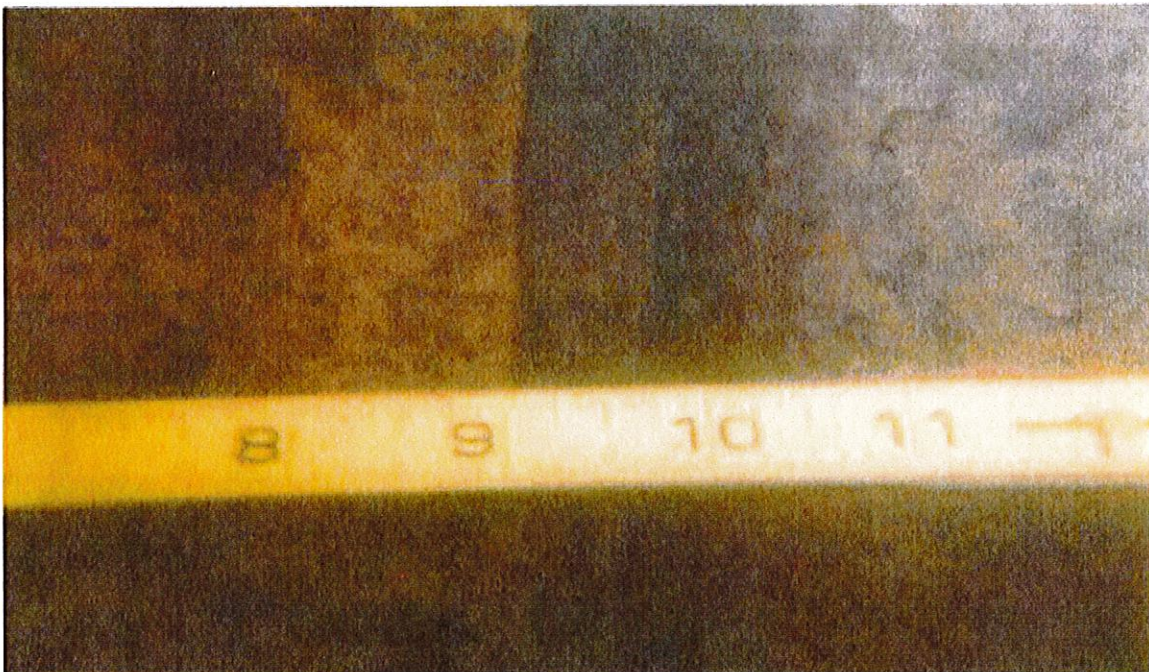
- 2.8.15 A 1.5-inch wide vertical gap at the midpoint shore side of the pier. It was very regular and seemed formed, that is it did not seem to have been the result of concrete deterioration. (See Figure 6)

Figure 6. A 1.5 inch vertical gap located underwater approximately at the midpoint on the shore side of Pier 3

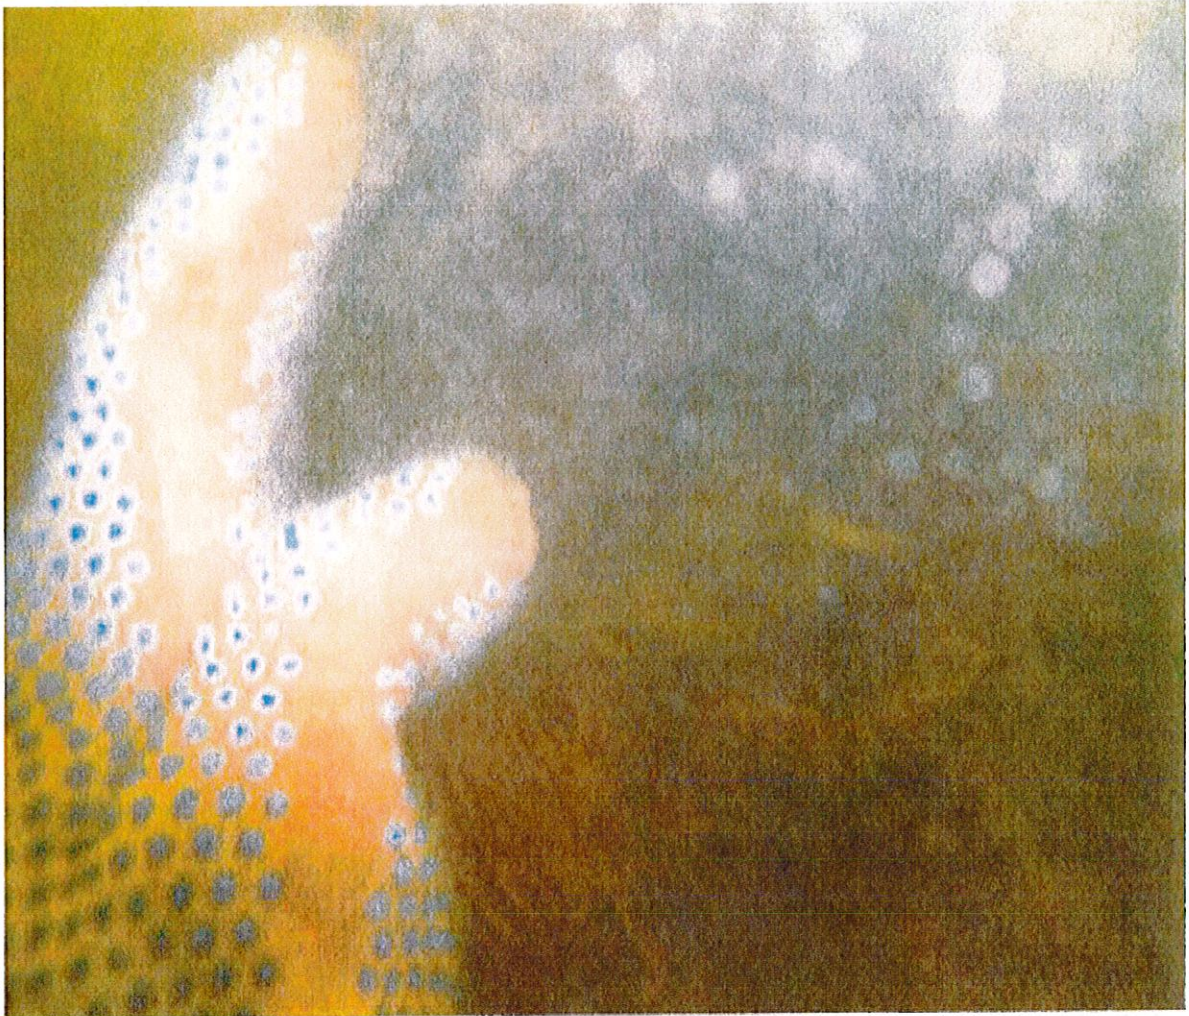
- 2.8.13 A 9-inch x 9-inch timber, apparently from the original construction, rested atop the lowest bench of the footer. It lay all along the channel side from about the point of the break for the point of the pier's to the point of the above-mentioned missing corner.

Figure 7. A wooden timber found underwater extruding out approximately 6" from the shore side of Pier 3.
